PROTECTION OF AIRCRAFT FLUID SYSTEMS

LTV Aerospace Corporation

TECHNICAL REPORT AFML-TR-68-125

May 1968

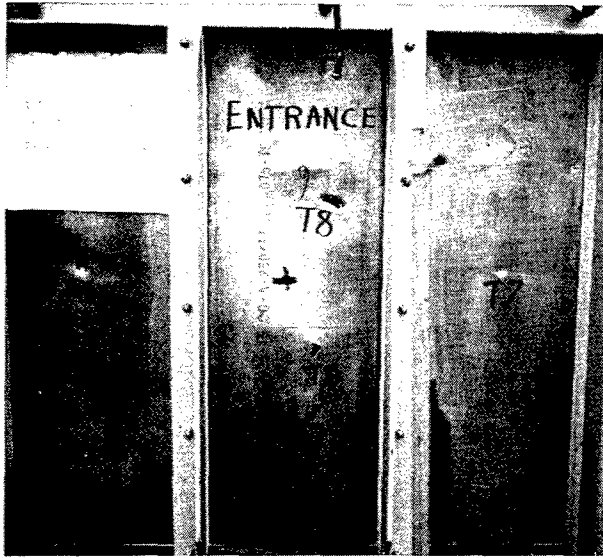
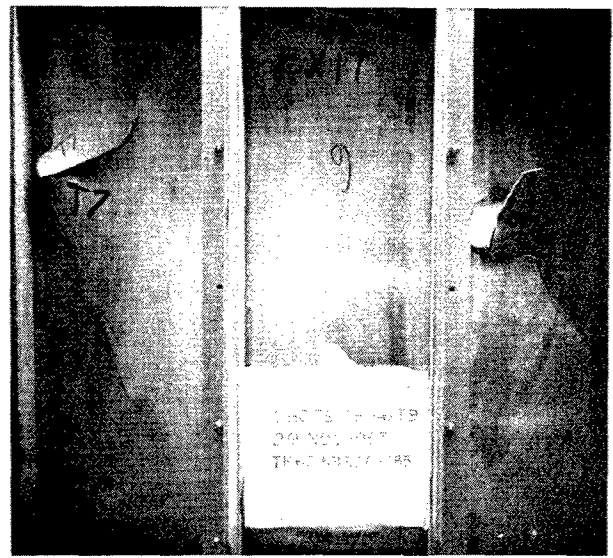
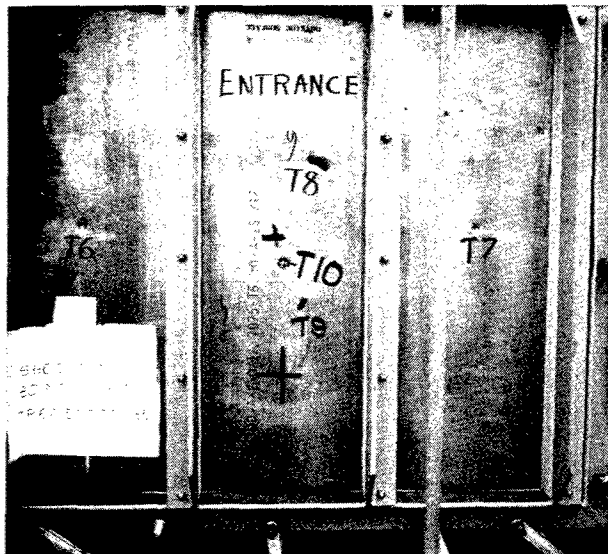
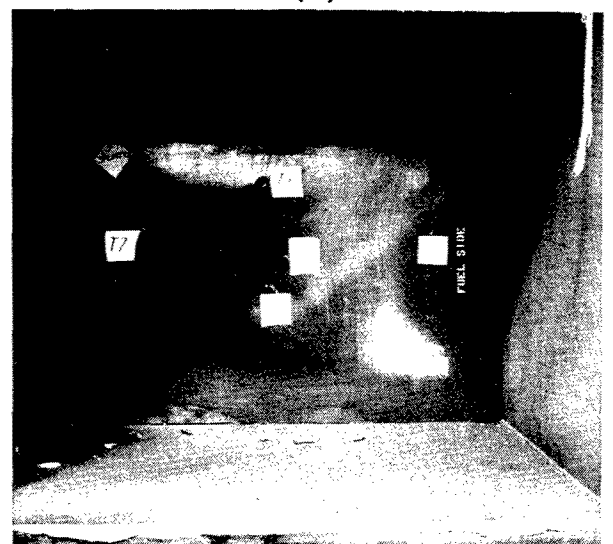
APPENDIX H  
PHOTOGRAPHS - WET TANK FIRING

Figure H-1 Photographs, Blocks B8, B8.1

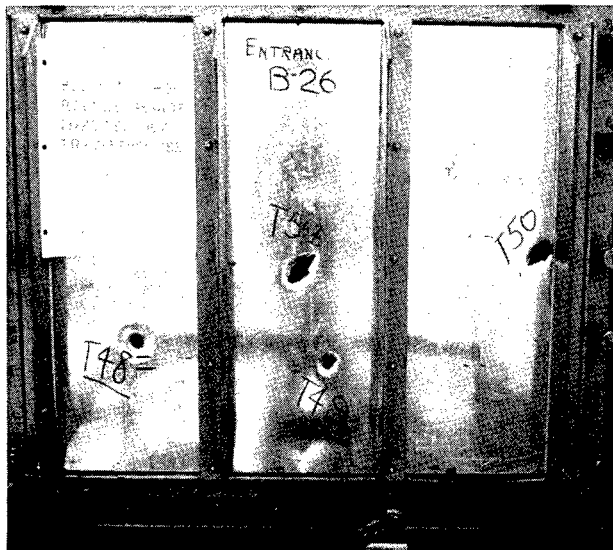
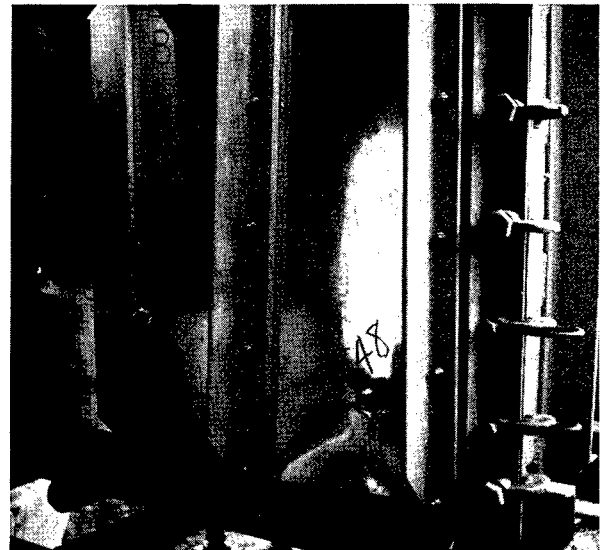
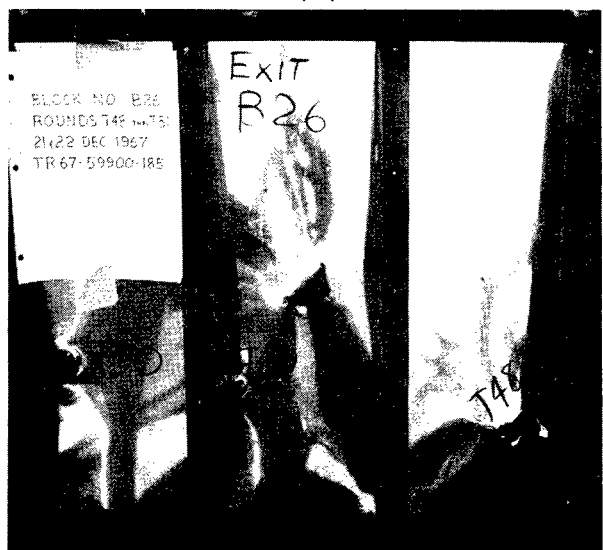
Figure H-2 Photographs, Block B26

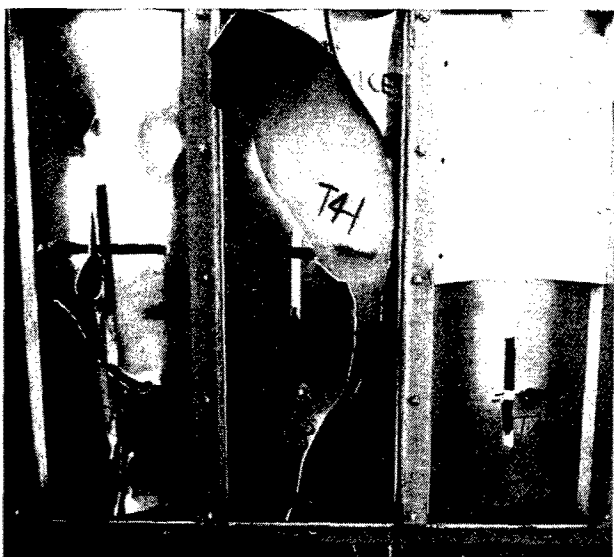
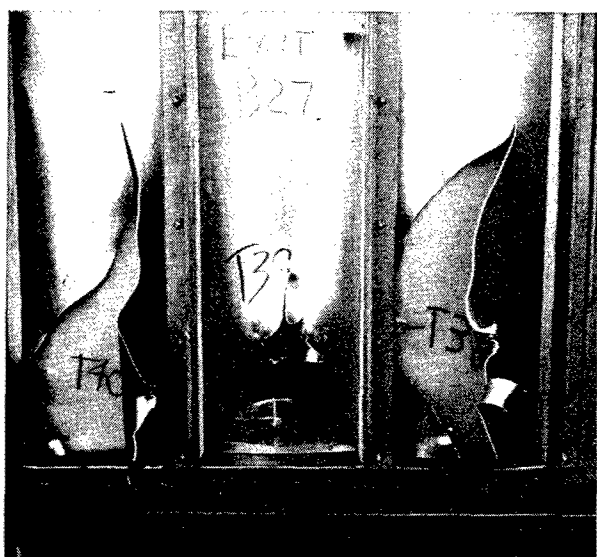
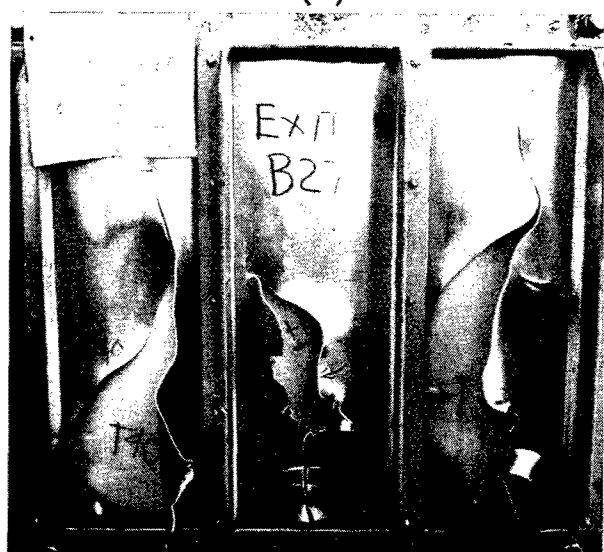
Figure H-3 Photographs, Block B27
